# Installation instructions Opel repair kit Charge pipe for B/D20DTH/R

The engines are installed in the Insignia A, Insignia B, Zafira C and Cascada.

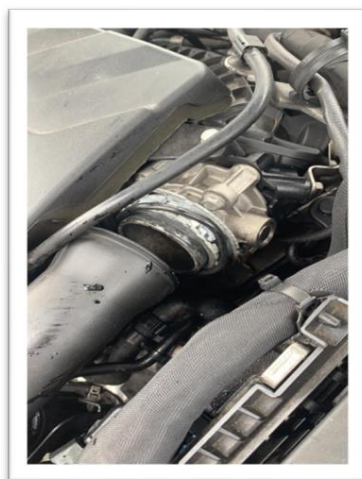
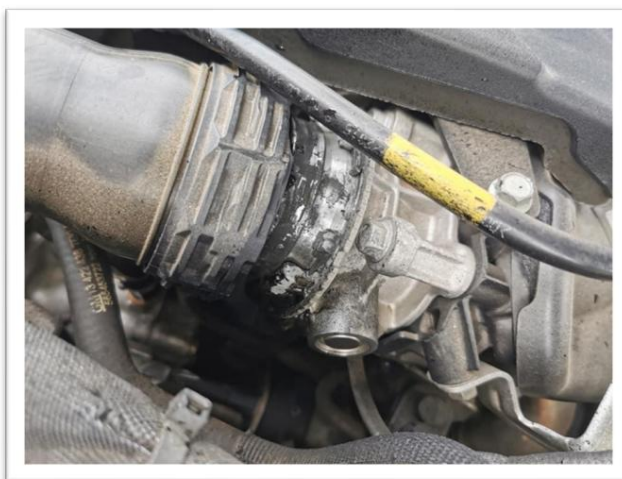
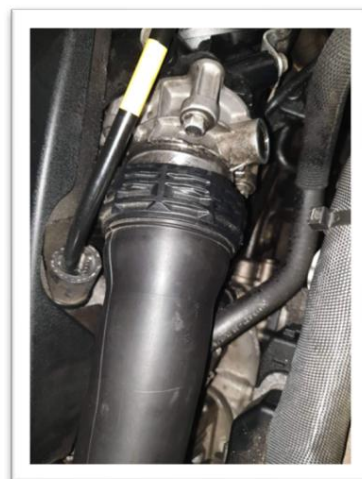
Like many modern turbocharged engines, the engine generation of the B/D20DTH/R series suffers from a connection between the charge air pipe and the throttle valve that is not permanently designed for the high boost pressure. This is made of plastic and cannot withstand the loads permanently. The result is torn connection pieces of the charge air pipe on the throttle valve.

The damage patterns shown above are commonplace with these engines, the replacement part installed by Opel for around €250.00 is not significantly more robust than the part installed in the factory. We therefore recommend a cheaper repair that can also be carried out by technical laypeople, which is explained in more detail below.
